# Final Kaneohe Stream Bioassessment

Susan Burr presently with AECOS, Inc.

January 2003

Prepared for the Hawaii State Department of Health

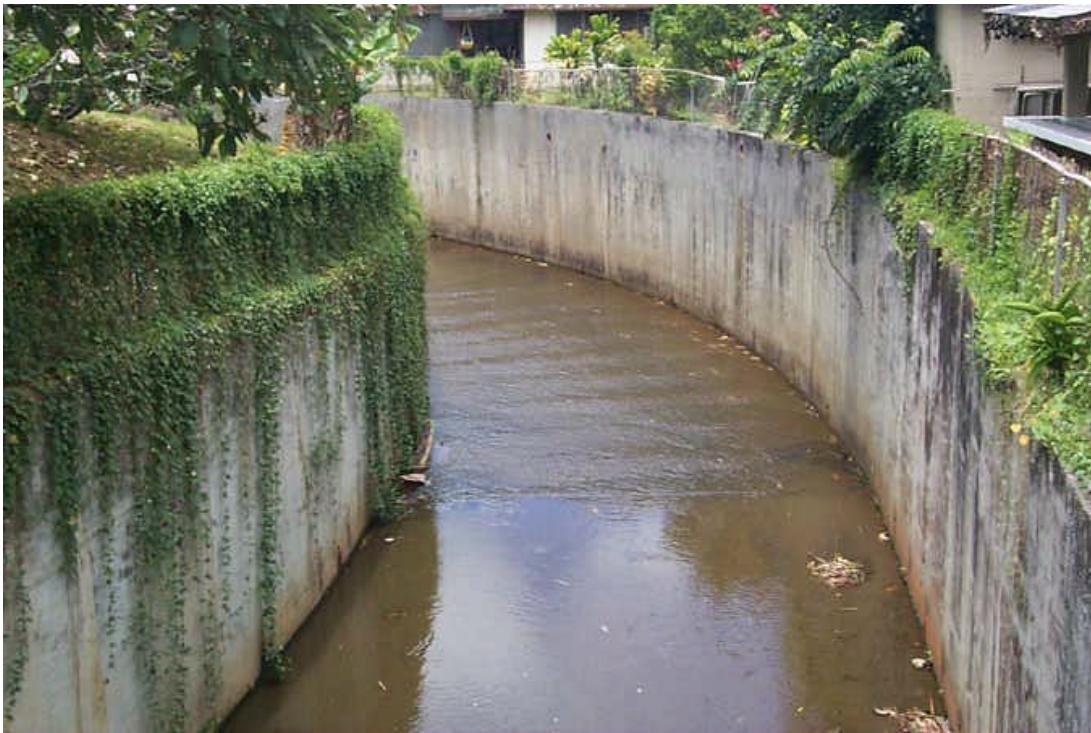
**Figure 5. Kamoo Bridge site.**

This section of the stream has been completely altered and functions more as a storm drain than a stream (Figure 5). The stream has been channelized and hardened as it flows through dense residential neighborhoods. Backyards abut a fence erected next to the channel, which has been designed to prevent access to the stream. No erosion is taking place, but neither are any natural processes, such as nutrient uptake in the riparian zone. The stream flows over the concrete bottom moderately fast, but is consistently shallow – good habitat for introduced poeciliids and a few armored catfish, but little else. This tributary is not connected to the Hoomaluhia Reservoir; therefore many of the exotic fish that have been introduced in the reservoir are absent in this tributary. One small native fish, an *Awaous guamensis*, was found during the survey.

<u>Habitat:</u>	
Score .....	84.7
Percent of statewide reference .....	42%
Degree of attainment of aquatic life use.....	Nonsupporting

Score .....	10
Percent of statewide reference .....	20%
Evaluation of aquatic life .....	Impaired

The Kamoo Bridge station has lost almost all of its naturalness and its ability to provide suitable habitat for native animals. The Kamoo Bridge station is unfortunately a typical example of an urban stream in Hawaii. The low habitat quality score and resulting low biotic integrity score demonstrates why past attempts to isolate the stream from the surrounding environment by hardening and straightening the channel have typically led to water quality problems and low bioassessment scores.

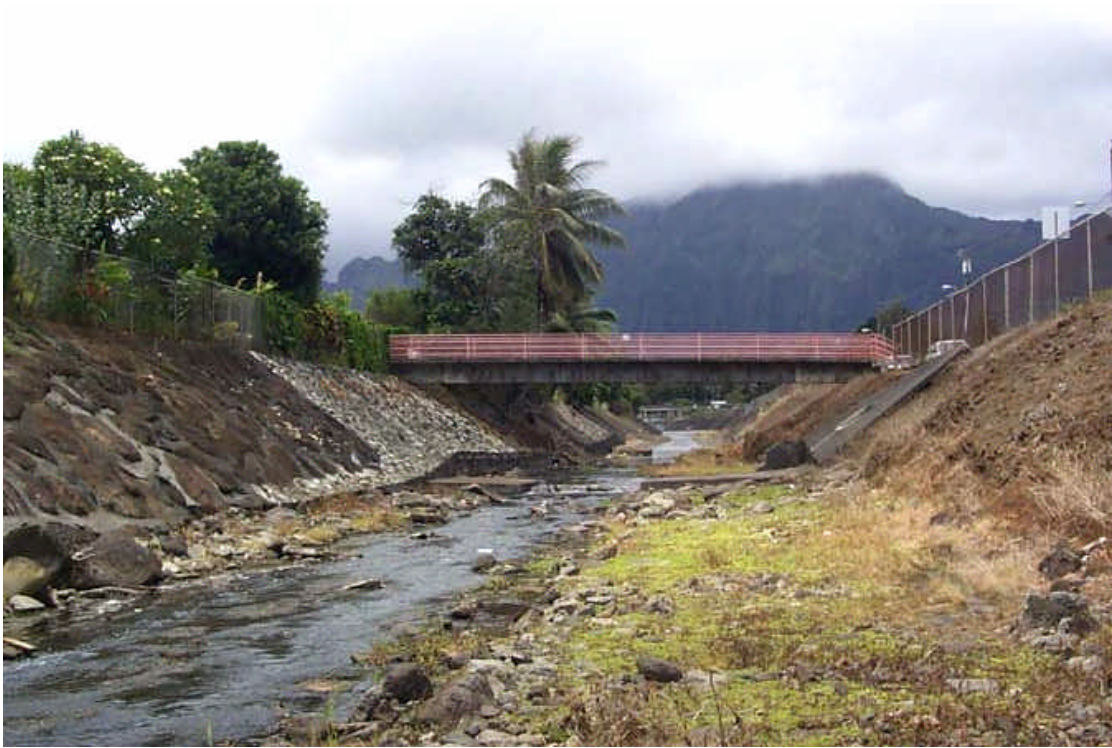
**Figure 6. Kamooalii Stream site.**

This section of Kamooalii tributary is located below the Hoomaluhia Reservoir and is a straightened channel with a natural bedrock-lined bottom (Figure 6). Houses and a road are adjacent to this residential section of the stream. A thick growth of the aquatic plant, *Vallisneria* sp., has reduced the number of different habitat types. Introduced fishes, primarily aquarium releases from the reservoir, dominate the abundant fauna at this site – in fact, no native fish were observed during the survey. The City and County of Honolulu maintains this section of the stream with the goal of minimizing flooding of the adjacent houses. While conducting the survey at this station, an herbicide-spraying truck followed us down the middle of the stream, spraying herbicides along the bank and immediately next to the water.

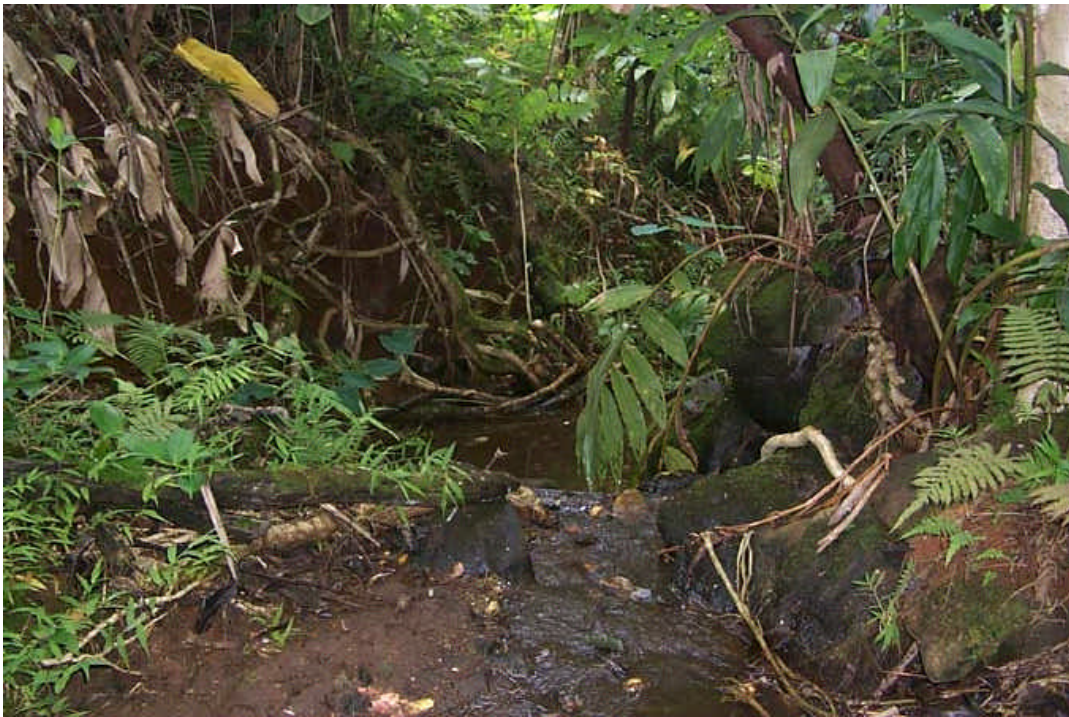
**Figure 7. Koolau Golf Course site.**

This section of the stream is the most natural when compared to the other sites surveyed, even though it is immediately next to the Koolau Golf Course (Figure 7). It has an intact riparian zone with a good understory and even a few native plants. This section of stream has a variety of habitats, although only two different flow regimes were present and the streambed exhibited evidence of sedimentation. Crayfish and guppies dominated the site, although small waterfalls and steps were home to an abundance of the native shrimp, *Atyoida bisulcata*. A large (26 cm) *Awaous guamensis* (‘o’opu nakea), a native fish, was found in this section of stream.

The Koolau Golf Course station is certainly the most natural of the three stations examined. The fairly steep stream channel is unaltered and the station has an intact riparian zone with a fair amount of understory and even some native trees (*Pandanus* sp.). However, the stream had a fair amount of sediment in it and not as much water as is expected, which eliminates habitat for native macrofauna and contributes to the *partially supporting* habitat score.

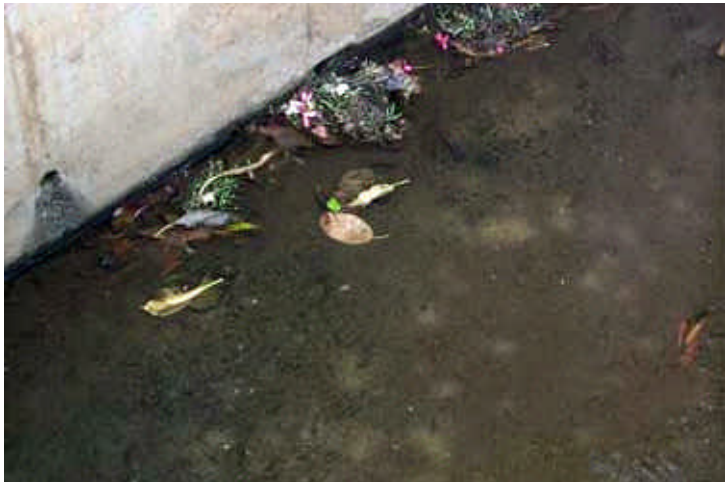
**Figure 8. Habitat at Kamoo Bridge site.**

The habitat score for the station at Kamoo Bridge, a completely hardened channel, is deceptively high, although still well below a supporting score (Figure 8). This site received perfect or near-perfect scores for embeddedness, sediment load, channel status, and bank stability – expected scores for a properly functioning storm drain. In contrast, the site received zero or near-zero scores for habitat availability, velocity-depths, channel alteration, riparian zone width, percent understory, and percent native riparian zone – poor scores for a properly functioning stream.

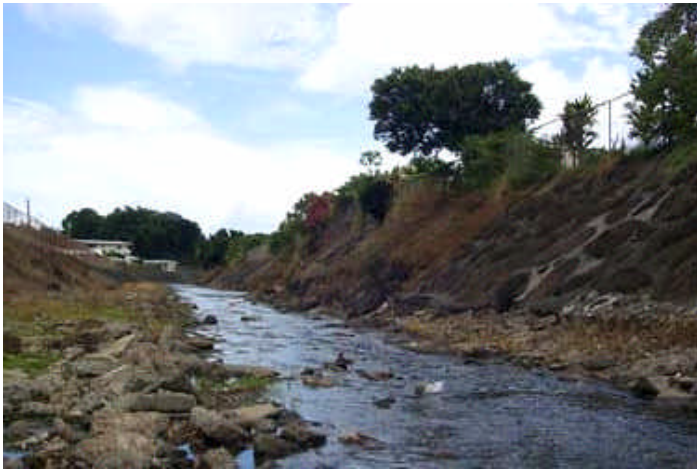
***Figure 9. Kamooalii Tributary site, looking downstream.***

The natural streambed in this otherwise altered stream provides habitat for a variety of fishes, although none of them are native (Figure 9). This section of the stream was choked with *Vallisneria* sp., an introduced aquarium plant that traps sediment entering the stream from the eroding banks and further upstream. This sediment is likely released into the water column and carried downstream during storms when the *Vallisneria* sp. is torn up and carried downstream by swiftly flowing waters. The banks of this section of the stream are quite steep and kept bare and eroding by City and County of Honolulu personnel who regularly spray herbicides from a tanker truck driving down the center of the stream. Houses line one side of the stream and a major road is adjacent to the

other. Development of the surrounding residential area has eliminated the riparian zone, and the understory is absent on the bare banks.

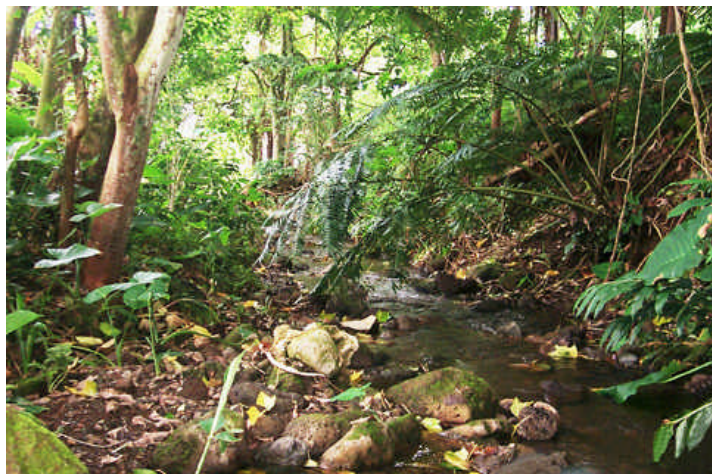
***Photograph 1: Primary Habitat at Luluku Gaging Station Site***

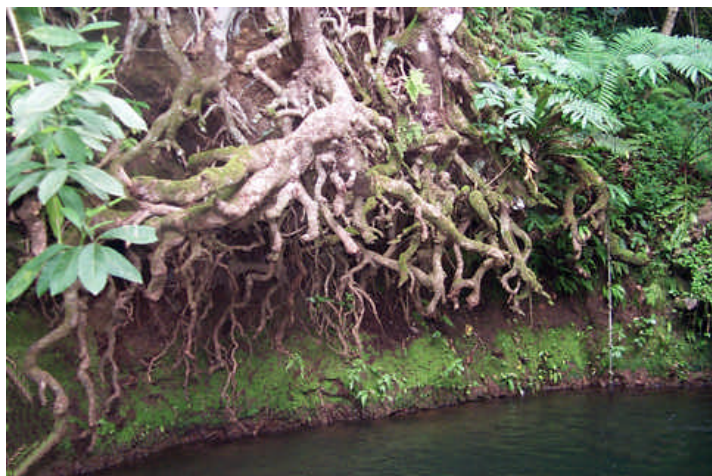
This site was originally thought to be minimally impacted by development. However, the habitat scores proved to be *non-supporting*, resulting in an *impaired* status for the biological integrity of the stream. The score for habitat quality was only 46% of the statewide reference condition while the biotic integrity was 18% of the statewide reference condition. Surprisingly, this site had much lower scores for habitat and biotic integrity than those for the Koolau Golf Course site. Also, the scores for biological integrity were slightly lower than those in the lower reaches of Kaneohe Stream due to the abundance of multiple alien species. This site assessment supports the findings of degradation in previous biological assessments conducted for Kaneohe Stream, but shows that even some portion of the upper reaches of Kaneohe Stream are degraded to a point that the habitat is non-supporting and the biotic integrity is therefore impaired.

***Photograph 3: Eroded Banks***
